## Smart I-V Curve Diagnosis Report

# **50MW PV Plant**

# **50MW PV Plant Smartlogger01 Smart I-V Curve Diagnosis**

# **50MW PV Plant Smartlogger01 PV string O&M report**

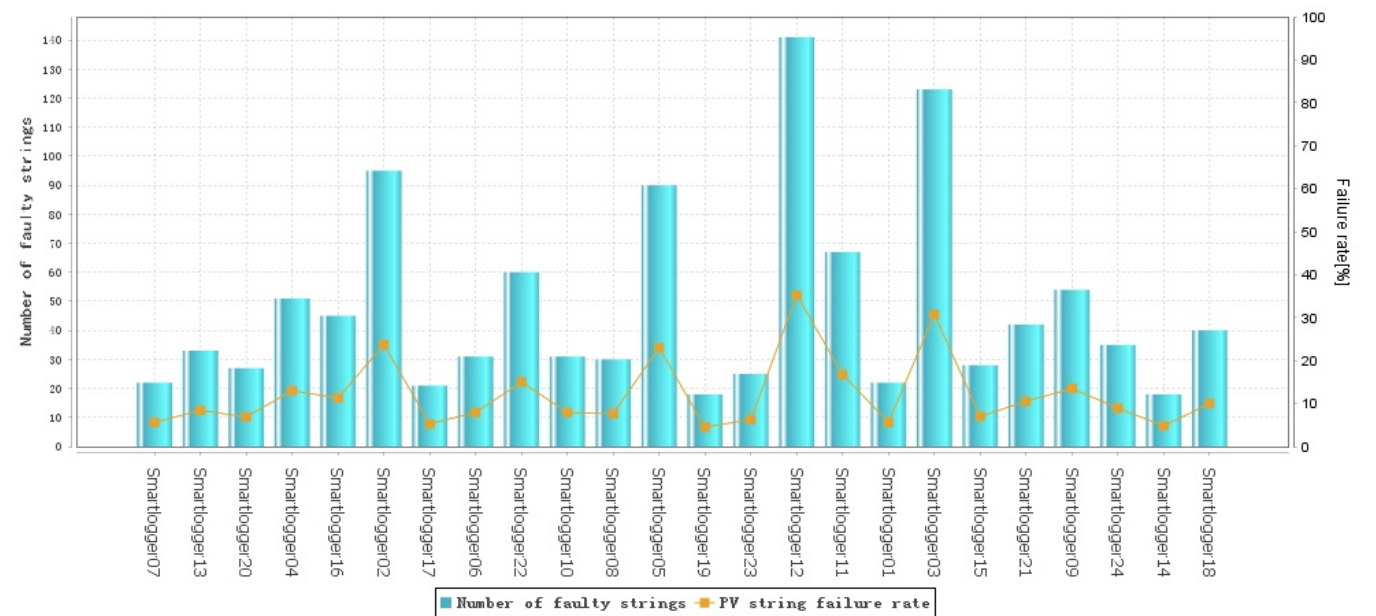
2. Fault Type Analysis

In total, 24 SmartLoggers are scanned in this task,1149 PV strings are faulty. The distribution is as follows: The common faults are:

- 1) PV module output current abnormal (shade/glass breakage/hidden crack), Percentage: 52.9%
  - 2) Current mismatch in the PV string (shade/dust/PV module current inconsistent), Percentage: 19.1%
  - 3) PV string open circuit (PV string breakage/PV string configured by mistake), Percentage: 18.4%
- First 3 common faults vs. total faults:90.4%

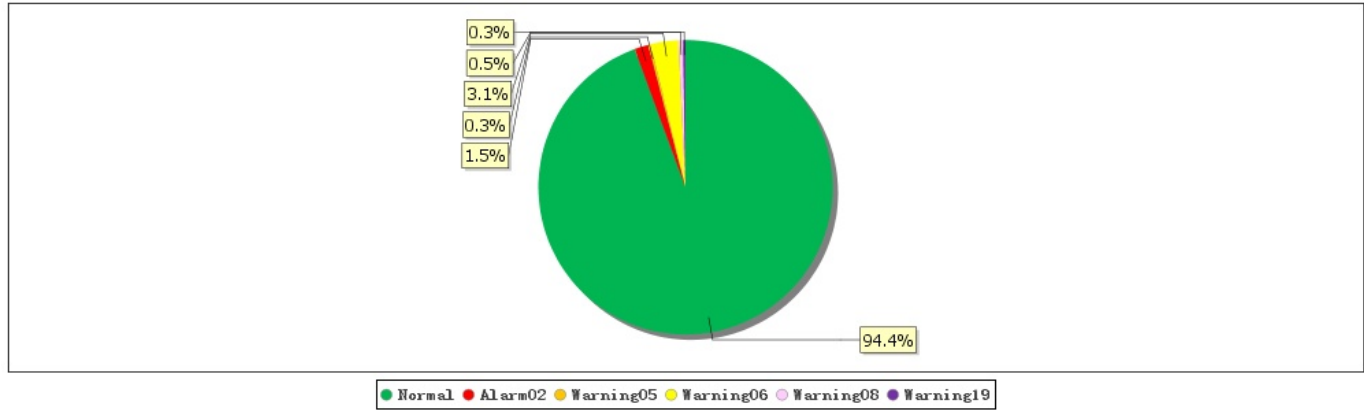
| Legend | Quantity | Percentage | Description |
|---|---|---|---|
| Alarm02 | 6 | 1.5% | PV string open circuit (PV string breakage/PV string configured by mistake) |
| Warning05 | 1 | 0.3% | Current mismatch in the PV string (shade/dust/PV module current inconsistent) |
| Warning06 | 12 | 3.1% | PV module output current abnormal (shade/glass breakage/hidden crack) |
| Warning08 | 2 | 0.5% | PV string voltage abnormal (diode short circuit/PV module invalid/PV module quantity incorrect) |
| Warning19 | 1 | 0.3% | Abnormal curve near MPP in the PV string (hotspot/hidden crack/glass breakage) |

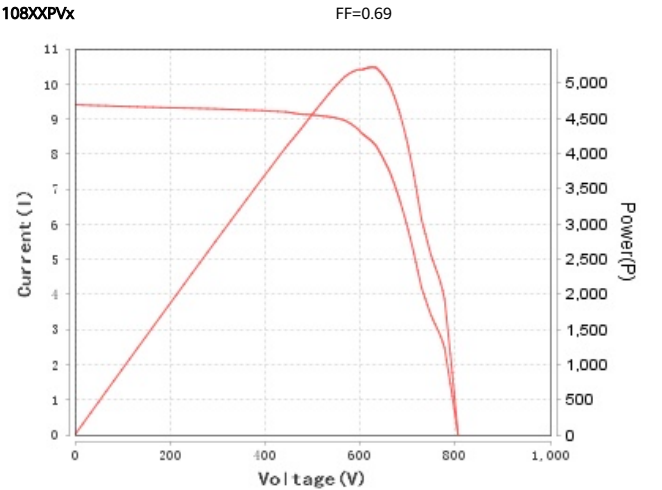
| Isc[A] | 9.40 | Imp[A] | 8.36 | Pmax[W] | 5224.58 |
| Voc[V] | 806.20 | Vmp[V] | 624.80 | PV module output current abnormal (shade/glass breakage/hidden crack) | |

| NO. | Description | Following advise |
|---|---|---|
| 2 | PV module output current abnormal (shade/glass breakage/hidden crack) | Step 1: Observe the PV string for shade. If there is shade, eliminate the shade and measure again.<br>Step 2: If there is no shadow on panel, check if there are foreign matters or dirt on the surface of the panel; if yes, then measure again after removing the foreign matters.<br>Step 3: If there is no shadow on the surface of panel, please check if there is broken glass; if yes, please measure again after replacing with same model of PV module.<br>Step 4: If no PV module has a broken glass panel, check whether the PV string has been cleaned. If not, clean the PV string and then measure again after the PV module surface is dry.<br>Step 5: If the PV string has been cleaned, scan the PV string using an infrared thermal imager to locate the abnormal PV module.<br>Step 6: If there is no fault, please identify the module with abnormal current by IV tester. |

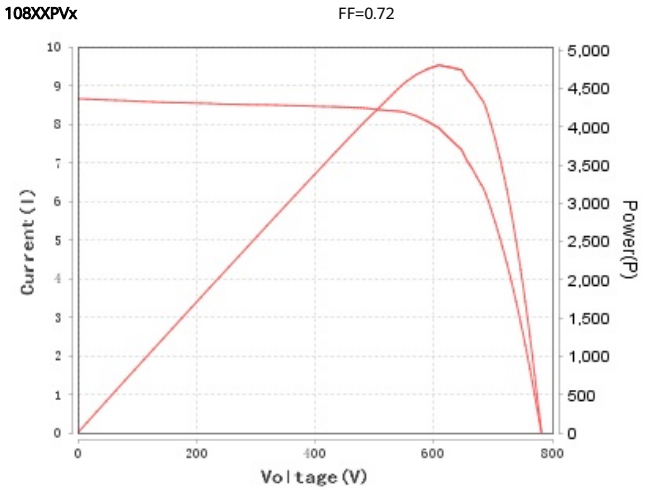
| Isc[A] | 8.65 | Imp[A] | 7.88 | Pmax[W] | 4808.63 |
| Voc[V] | 782.00 | Vmp[V] | 610.00 | PV string voltage abnormal (diode short circuit/PV module invalid/PV module quantity incorrect) | |

| NO. | Description | Following advise |
|---|---|---|
| 5 | PV string voltage abnormal (diode short circuit/PV module invalid/PV module quantity incorrect) | Step 1: Check whether the number of PV modules connected to the PV string is correct.<br>Step 2: Observe whether there are traces of burning at the interconnection strip, backsheet, and wiring box. If so, replace the PV module with the same model.<br>Step 3: If none of the above exists, please use IR camera to check if there is short circuited diode or broken ribbon for interconnection.<br>Step 4: If there is no abnormal found on the module with IR camera, please use voltage meter to check the voltage of the strings (from same MPPT), to see if it is too low. And if yes, please measure the temperature of panels in string to check whether there is abnormal temperature distribution. |

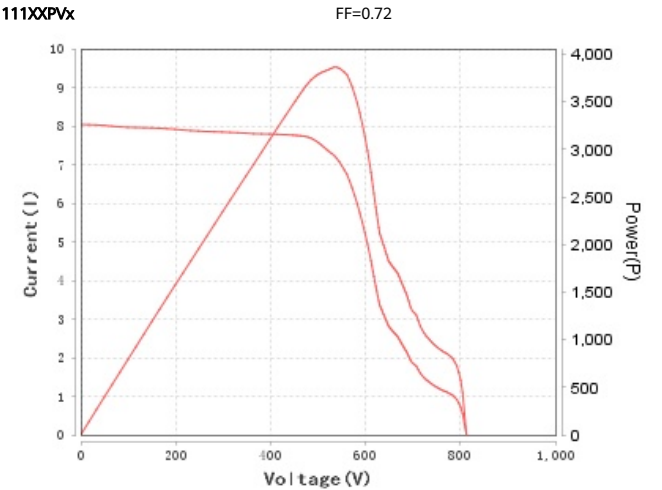
| Isc[A] | 8.04 | Imp[A] | 7.24 | Pmax[W] | 3863.64 |
| Voc[V] | 812.80 | Vmp[V] | 533.80 | PV module output current abnormal (shade/glass breakage/hidden crack) | |

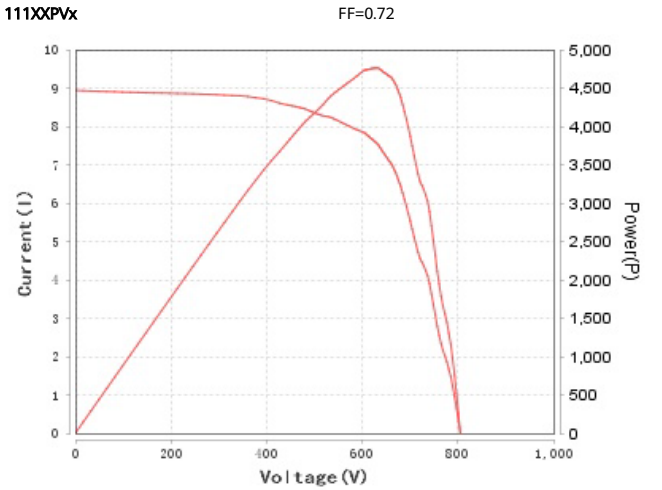
| Isc[A] | 8.94 | Imp[A] | 7.54 | Pmax[W] | 4766.16 |
| Voc[V] | 805.30 | Vmp[V] | 632.20 | Current mismatch in the PV string (shade/dust/PV module current inconsistent) | |

| NO. | Description | Following advise |
|---|---|---|
| 3 | Current mismatch in the PV string (shade/dust/PV module current inconsistent) | Step 1: Please check if the scanning is done at a sunny day, current mismatch may occur when the irradiance changes dramatically.<br>Step 2: Check if there is shadow; if yes, please measure again after removing the shadow.<br>Step 3: If no, please check string was cleaned.<br>Step 4: If the PV string has not been cleaned, clean the PV string and then measure again after the PV module surface is dry.<br>Step 5: If string was cleaned, please check if there are panels with low Isc or from other power class by IV testing of each panel. |
