# HUAWEI SUN2000-5/6KTL-M1 Inverter Low Insulation Resistance Fault Indication Guide

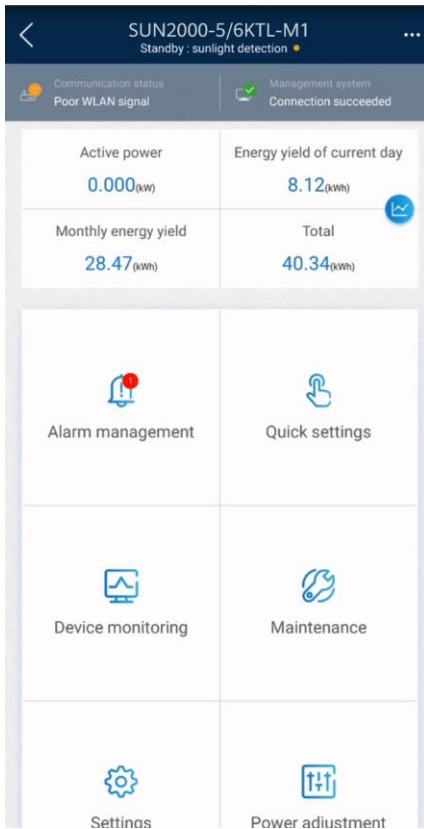
Click 'Alarm Management'

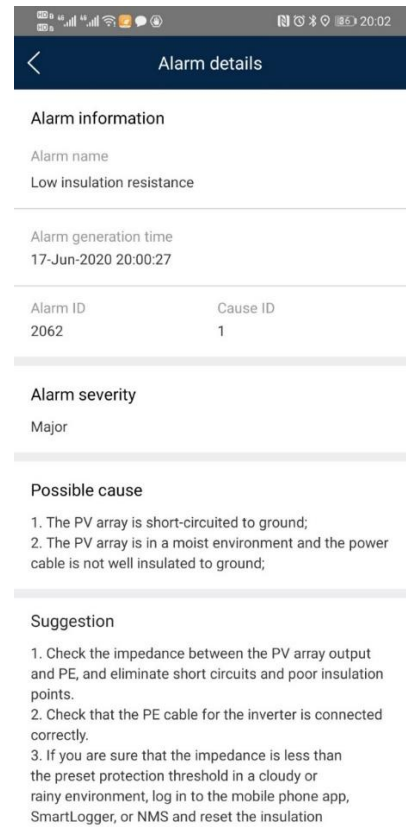
Select 'Low Insulation resistance' alarm
