# HUAWEI SUN2000-2-6KTL-L1 Inverter Low Insulation Resistance Fault Indication Guide

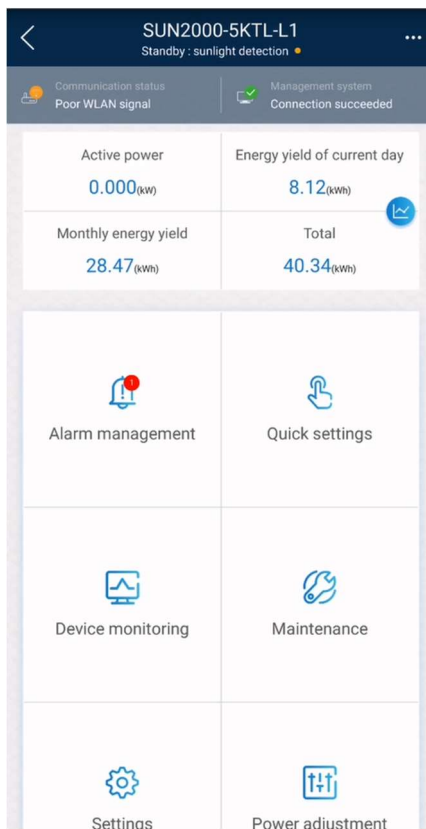
Click 'Alarm Management'

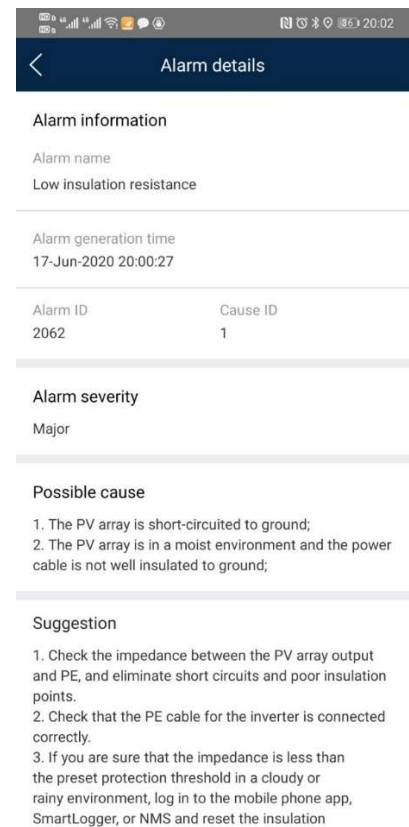
Select 'Low Insulation resistance' alarm
