Upgrading Software – SUN2000L inverters

Huawei Technologies Co. Ltd.

Version	Created by	Date	Remarks
01	Huawei 84093577	10.01.2019	SUN2000L

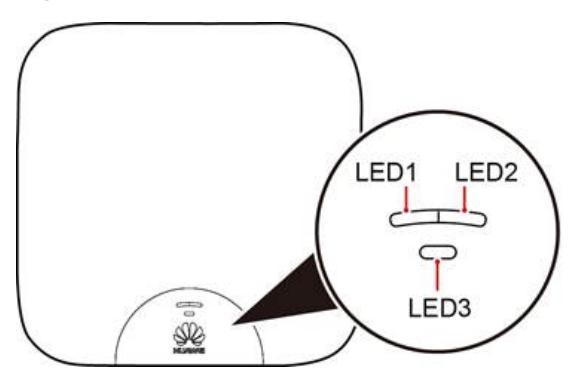
Figure 1-1 LED indicators

Software upgrade failed.

- The app version is not the latest.
- The DC side is not energized, the LED1 indicator of the SUN2000L is off, and the delayed upgrade function is disabled.
