Battery switch trip

Huawei Technologies Co. Ltd.

Version	Created by	Date	Remarks
01	Huawei 84081311	10.01.2019	SUN2000L

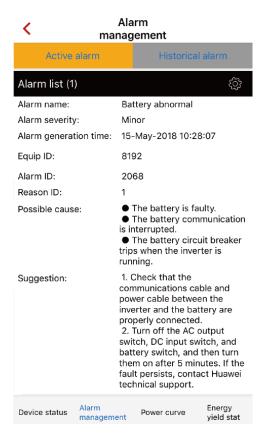
The battery switch trips, and the FusionHome app reports the **Battery Abnormal** alarm. Battery abnormal:

The battery cable is incorrectly connected.

Too many PV modules are configured. The maximum open-circuit voltage of PV modules exceeds 495 V DC.
