# HUAWEI SUN2000-50KTL-M0 Inverter Low Insulation Resistance Fault Indication Guide

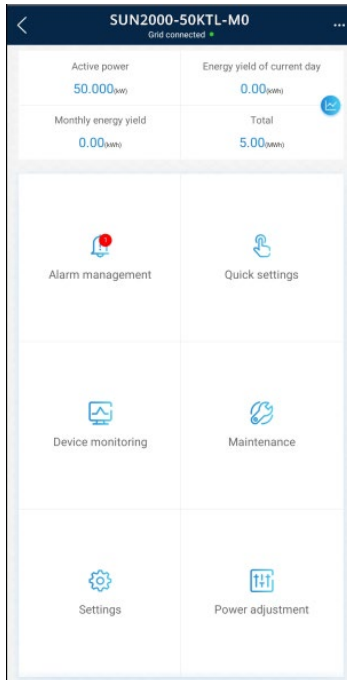
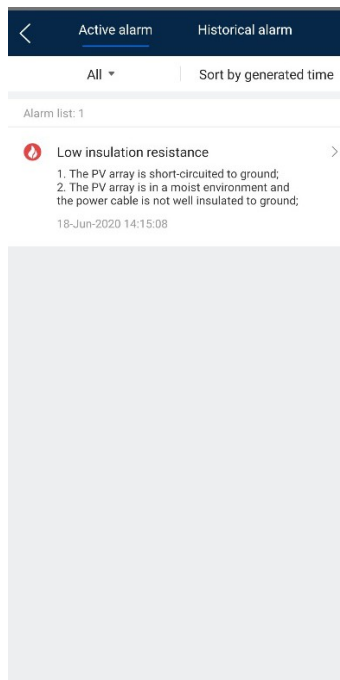
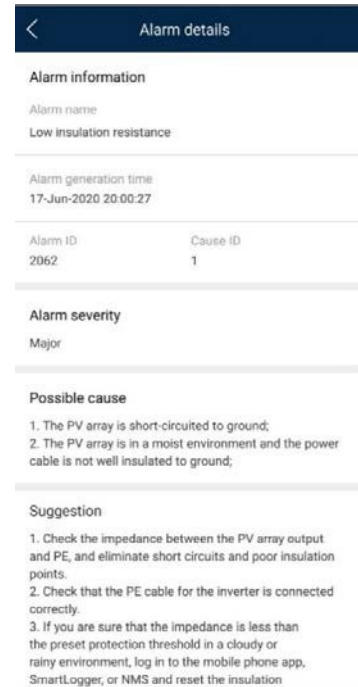
- When connecting FusionSolar App to inverter via its built-in WLAN communication, low insulation resistance alarm or fault can be indicated via following interface by:

Click 'Alarm Management'

Select 'Low Insulation resistance' alarm
