HUAWEI SUN2000-2-6KTL-L1 and SUN600-5/6KTL-L0 Inverter Low Insulation Resistance Fault Indication Guide

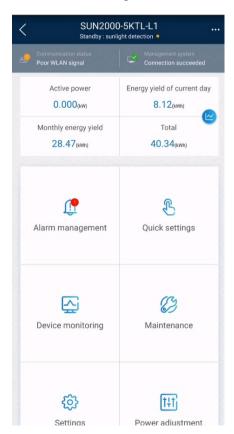
Click 'Alarm Management'

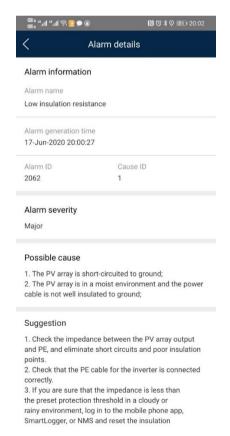
Select 'Low Insulation resistance' alarm
