## Smart I-V Curve Diagnosis Report

# **50MW PV Plant**

# **50MW PV Plant Smartlogger01 Smart I-V Curve Diagnosis**

# **50MW PV Plant Smartlogger01 PV string O&M report**

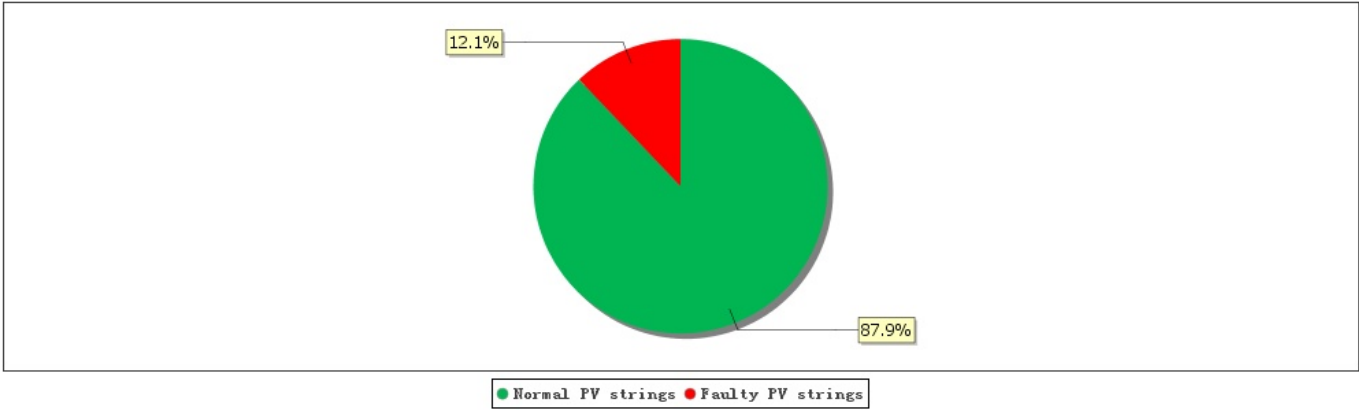
1. Evaluation of the PV String Failure Rate

In total, 9496 PV strings are scanned in this task. Faulty PV strings: 1149Total failure rate: 12.1%

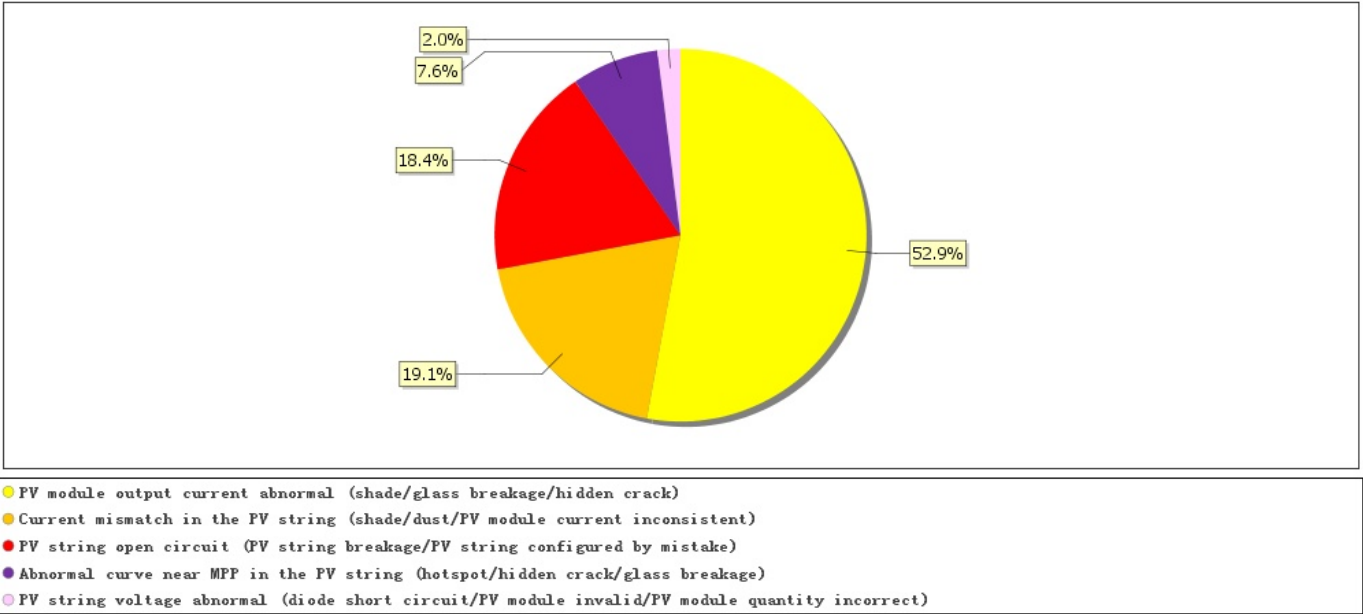
In total, 24 SmartLoggers are scanned in this task,1149 PV strings are faulty. The distribution is as follows: The common faults are:

- 1) PV module output current abnormal (shade/glass breakage/hidden crack), Percentage: 52.9%
  - 2) Current mismatch in the PV string (shade/dust/PV module current inconsistent), Percentage: 19.1%
  - 3) PV string open circuit (PV string breakage/PV string configured by mistake), Percentage: 18.4%
- First 3 common faults vs. total faults:90.4%

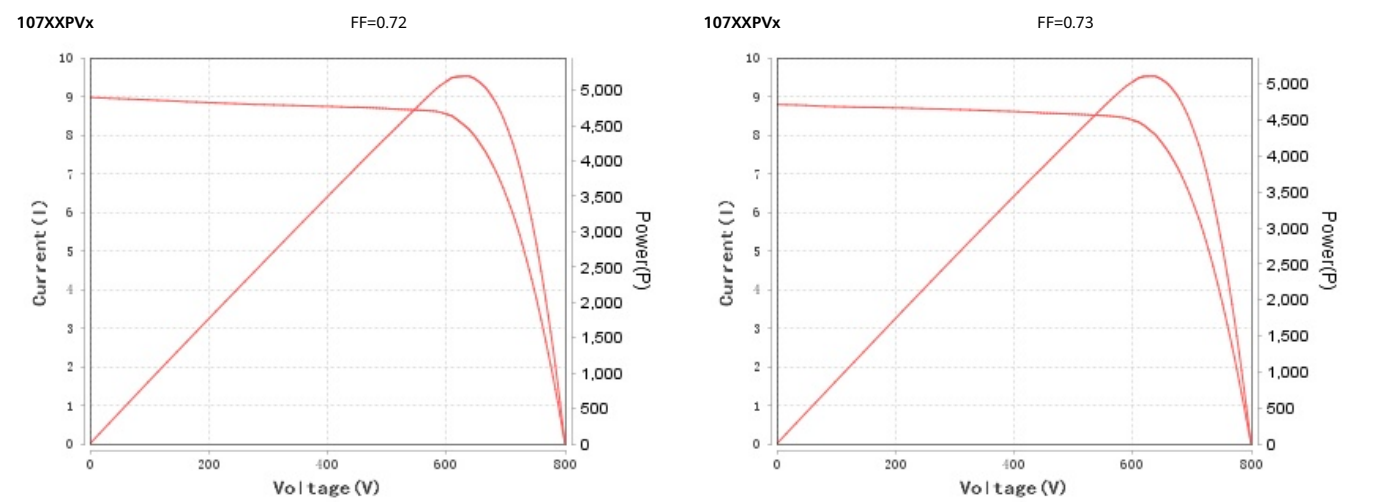
| Isc[A] | 8.97 | Imp[A] | 8.15 | Pmax[W] | 5199.98 |
| Voc[V] | 799.70 | Vmp[V] | 637.80 | PV string normal | |
