# HUAWEI SUN2000-8-20KTL-M2 Inverter Low Insulation Resistance Fault Indication Guide

HUAWEI single phase residential inverter SUN2000-8/10/12/15/17/20KTL-M2 inverter has followed the requirement of AS 4777.2:2015 to detect earth fault via check the insulation resistance value. The fault is depicted in following table:

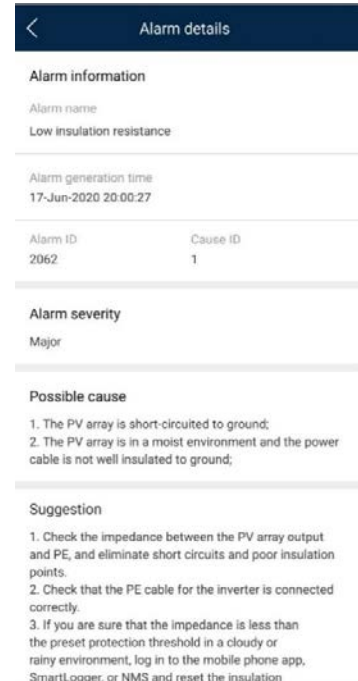
- When connecting FusionSolar App to inverter via its built-in WLAN communication, low insulation resistance alarm or fault can be indicated via following interface by:

Click 'Alarm Management'

Select 'Low Insulation resistance' alarm
