HUAWEI SUN2000-20-40KTL-M3 Inverter

Low Insulation Resistance Fault Indication

Guide

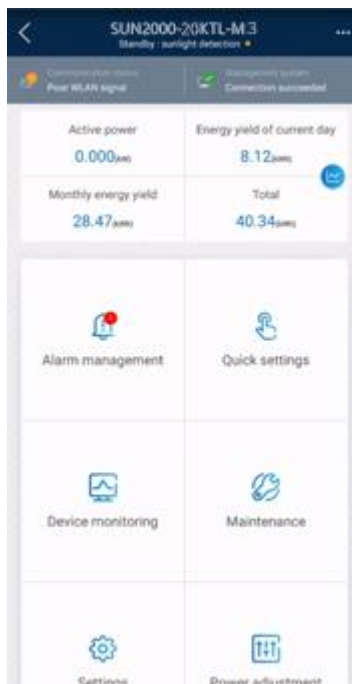
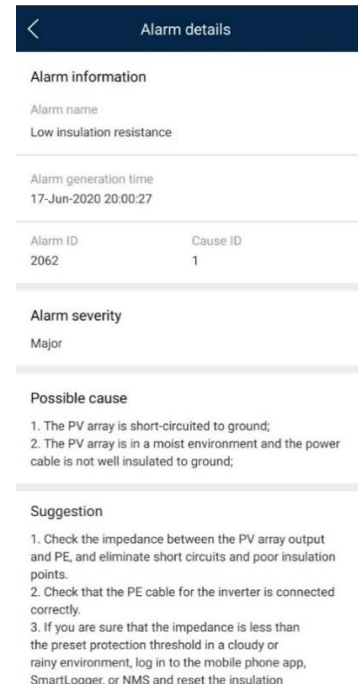
- When connecting FusionSolar App to inverter via its built-in WLAN communication, low insulation resistance alarm or fault can be indicated via following interface by:

Click 'Alarm Management'

Select 'Low Insulation resistance' alarm
