HUAWEI SUN2000-100KTL-M1 Inverter Low Insulation Resistance Fault Indication Guide

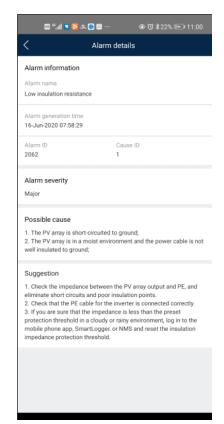
When connecting FusionSolar App to inverter via external WLAN adaptor, low insulation resistance alarm or fault can be indicated via following interface by:

Select "Low Insulation Resistance" alarm
