HUAWEI SUN2000-8-20KTL-M2 Inverter Low Insulation Resistance Fault Indication Guide

HUAWEI three phase residential inverter SUN2000-8/10/12/15/17/20KTL-M2 inverter has followed the requirement of AS 4777.2:2020 to detect earth fault via check the insulation resistance value. The fault is depicted in following table:

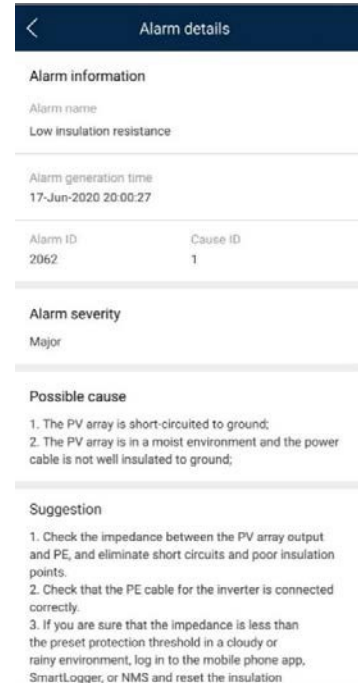
- When connecting FusionSolar App to inverter via its built-in WLAN communication, low insulation resistance alarm or fault can be indicated via following interface by:

Click 'Alarm Management'

Select 'Low Insulation resistance' alarm
