TEST REPORT

Name of Customer: Huawei Technologies Co., Ltd.

Test Name: Salt Spray Test

Table 1. Description of sample			
Sample name	Model	Serial No	Quantity
Network Energy	SUN2000-90KTL-H0 SUN2000-90KTL-H1 SUN2000-95KTL-INH0 SUN2000-100KTL-H0 SUN2000-100KTL-H1 SUN2000-100KTL-H2	/	1pcs

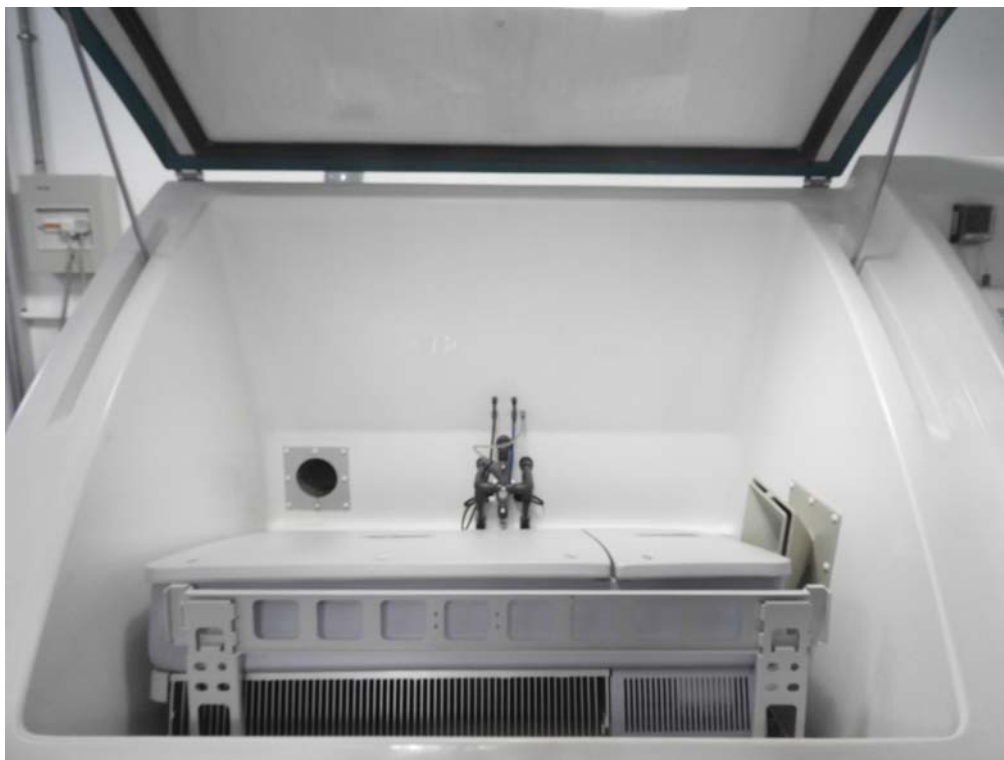
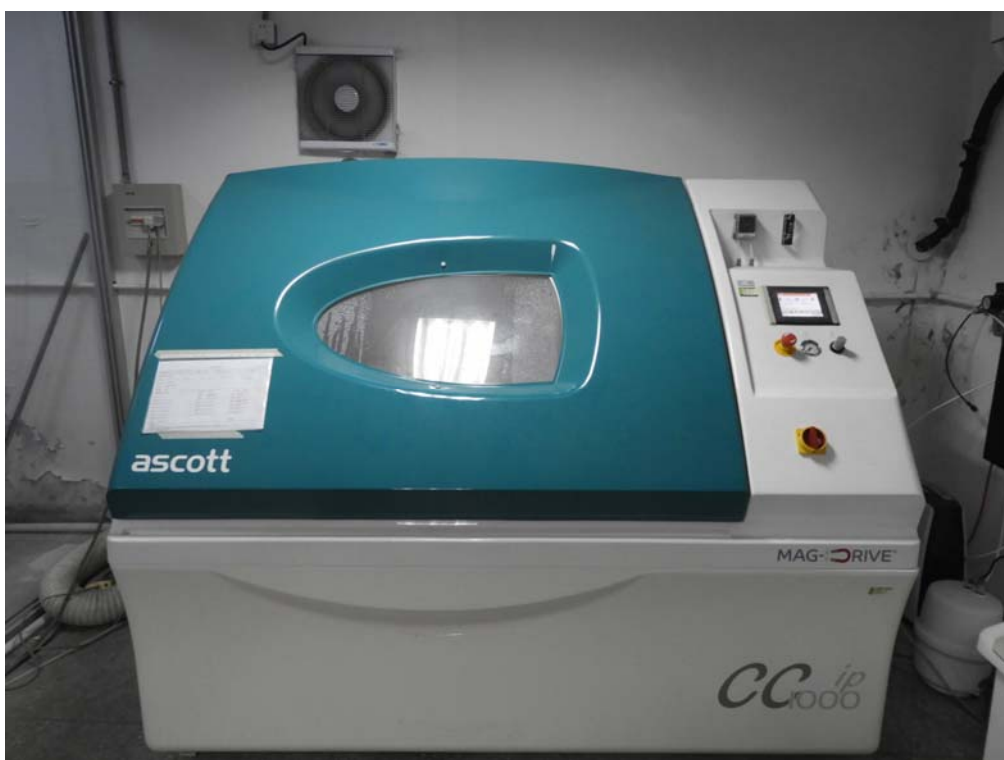
Setup Photos

Table 3. Test Condition		
1	Chamber temperature	+35°C
2	Solution concentration	5%NaCl
3	PH	6.8
5	Settlement	1.5ml/80cm ² /h
6	Test duration	168h(2h Spray salt, 166h 40°C 93%RH), total 4 cycles
7	Environment temperature	23°C

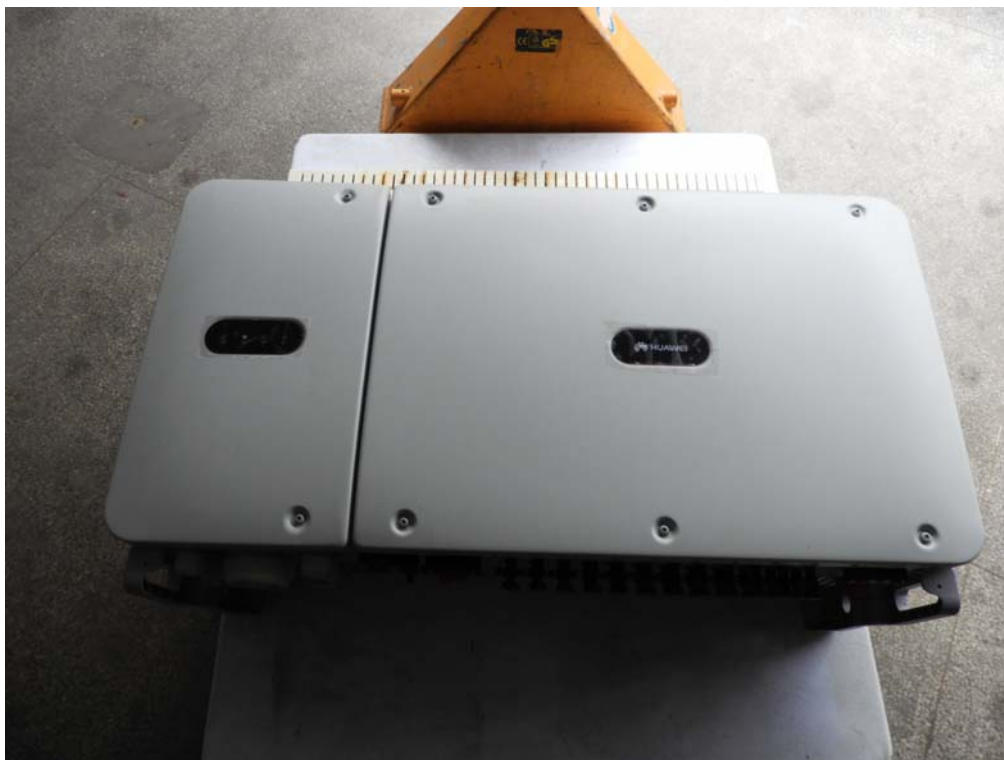
After Test

1. This test is only offered to meet the requirements of IEC 60068-2-52: 2017, meet the standard requirements;
2. During the test, the surface of the sample was visually checked for no corrosion, and no abnormalities such as deformation or breakage were observed;
3. The contents of attachment: Table 4.
